THE TOWN PATH

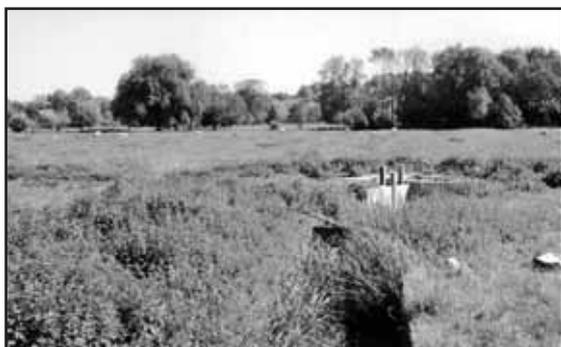
Sluice 20 - photo by M Cowan

'...when complete the wooden frame will house two large wooden hatch boards (or paddles), raised and lowered by two steel racks and pinion devices to control the flow of water. Damage to the stone walls of the watercourse has been stabilized with cement. Part of the floor cleared of mud and rubble reveals stone blocks laid longitudinally across the carriage and secured laterally by iron cramps, sealed with lead to prevent the iron rusting and damaging the stone. They appear to have done this successfully for some three centuries as the stone is judged to have come from the Hurdcott quarry some six miles west of Salisbury, geologically Upper Greensand, in the late seventeenth or early eighteenth century'. (I am grateful to Tim Tatton-Brown for this identification)'

In the last issue (No 28) I started at the Harnham end and stopped after describing the structures at the mid point. En route I observed that by the time the piece was published restoration work on Sluices 8 and 20 might have started. In the event it was very nearly finished but I hope some of you had a chance to see work in progress. The picture below was taken in August 2005 and I have used it as the frontispiece in *Wiltshire Water Meadows* (Hobnob Press 2005): it seems to represent three important aspects of the meadows - their history, a period of dereliction, and now restoration. Part of the caption reads

The re-building of Sluices 8 and 20 means that, in conjunction with the carriage from Sluice 18 at the centre reservoir, the way is open to being able eventually to drown (or irrigate) some half of the Eastern Meadows.
